# Landforms and Landcover

# 2.1 Grassland (Pasture and Tussock)

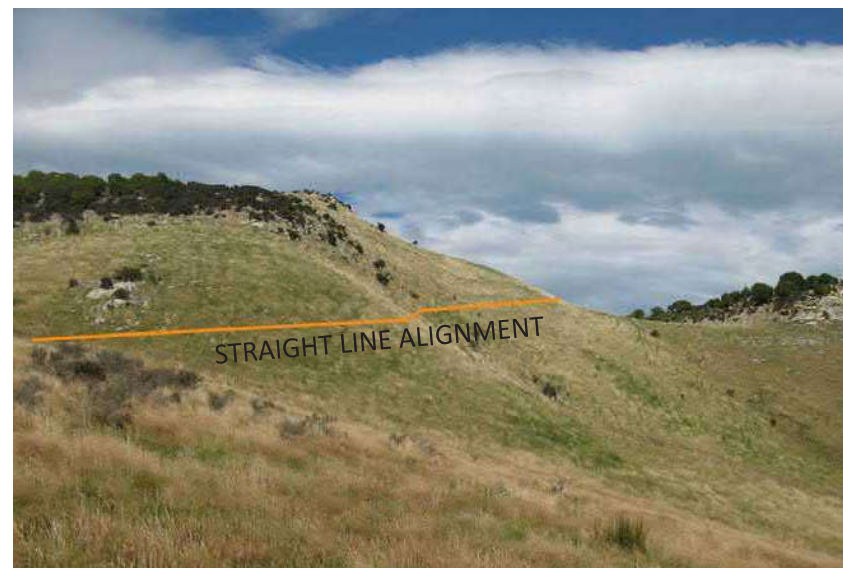
Fig. 5 Before: Straight line alignment of road.

For straight line alignments the following measure is to be applied to reduce the visibility of the straight lines:

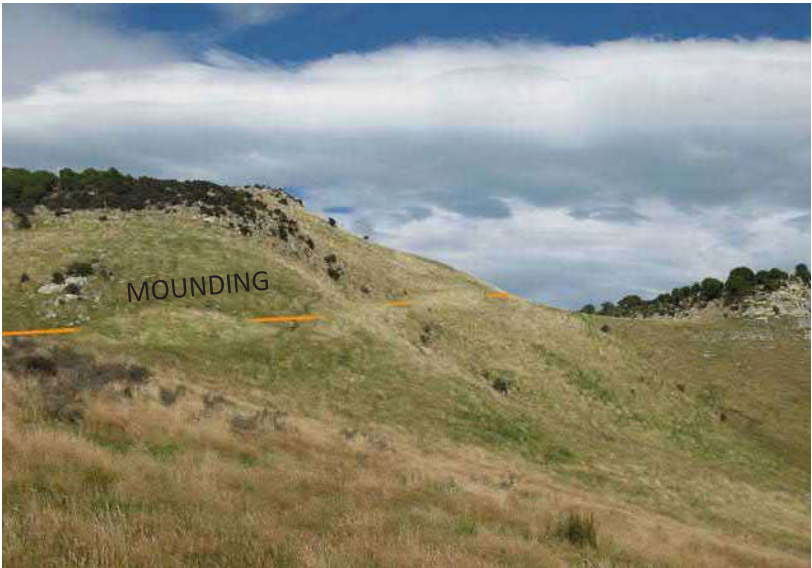
Fig. 7 After: Add fill material to create mounds or vegetation to reduce impact of road.

Strip the grassland and soil off the road and place into a mounded area on the downhill side of the road, texture the cut surface so that organic matter will fill the crevices, mound the downhill side of the road to obscure part of the straight line alignment.

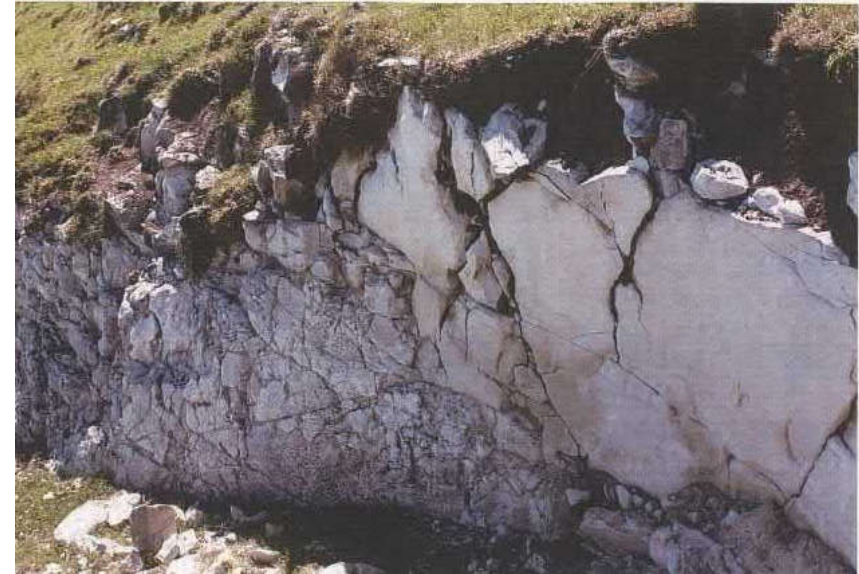
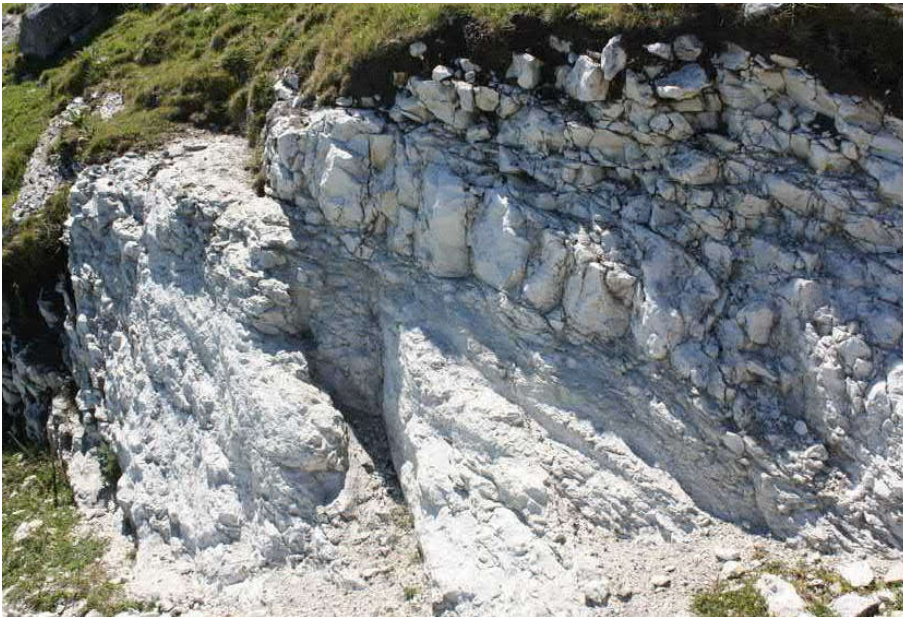
Fig. 27 Striated texture of Amuri Limestone. Organic matter collects in the crevices and ledges.

The Amuri limestone surface is to be textured in order to reduce the dominant cream colour characteristic. It is intended that organic matter from the site shall collect in the cracks, crevices and gaps and this will grow vegetative matter, thereby reducing the visibility of the cut material.

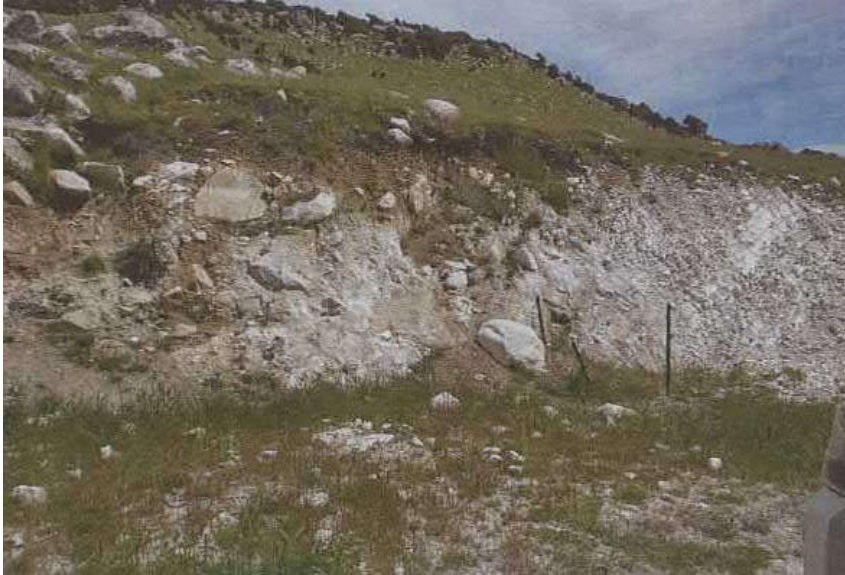
Fig. 30 & 31 A 1.8 – 5.0 m high cut batter constructed in an irregular fashion so that organic matter will accumulate. The organic matter shall be material which is sourced on site, with a seed mix added. The crest needs to be rounded off it is intended that planting shall take place at the base of the batter.

Topsoil will be removed, and the limestone face is cut to the batter slope above the road. The cut is to be irregular, as per condition 96, so that ledges and crevices are created to enable organic matter from the site to be placed on, within, or accumulate.

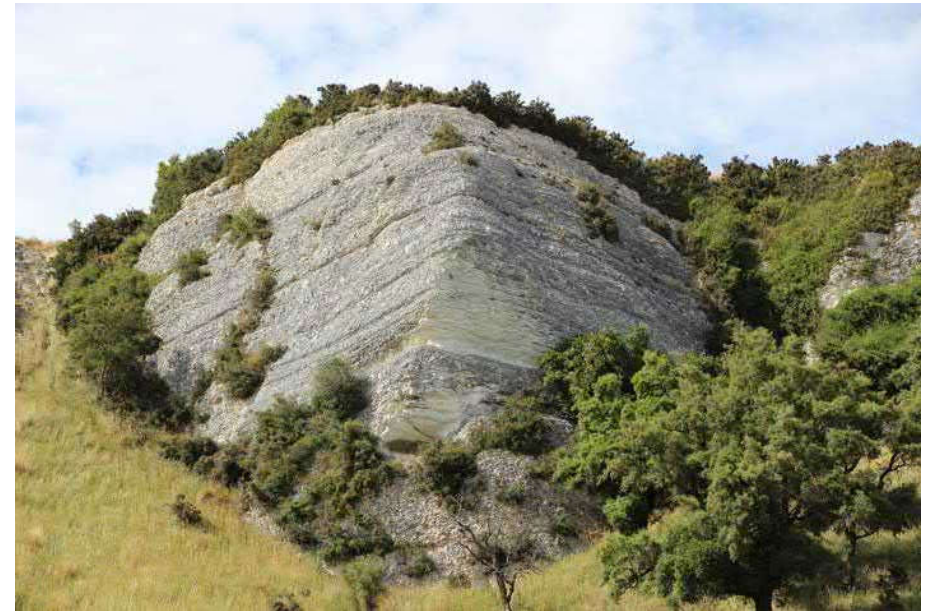
Fig. 34 A textured Amuri limestone outcrop.

Texturing the surface assists, along with the weathering process, to reduce the visual impact of flat and reflective cut faces. The objective is that the textured surface is deep enough, e.g. 25-50mm, for organic matter (ie: material collected on site) to accumulate. This is a passive mitigation technique, creating a rough surface that allows soil to accumulate. The more fragmented cut surfaces weather faster and allow vegetation to establish and so reduce visual effects.

To further speed the process, some discrete cuts and pockets are to be hydroseeded on the south side. Refer to Figure 34. This is an active mitigation technique. However, for the northern facing slopes this is unlikely to be effective, due to the dry site conditions.

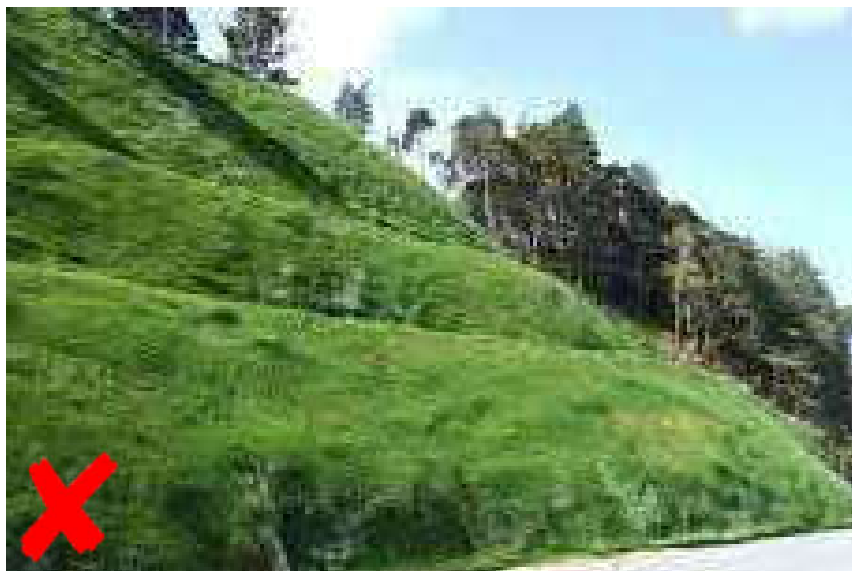
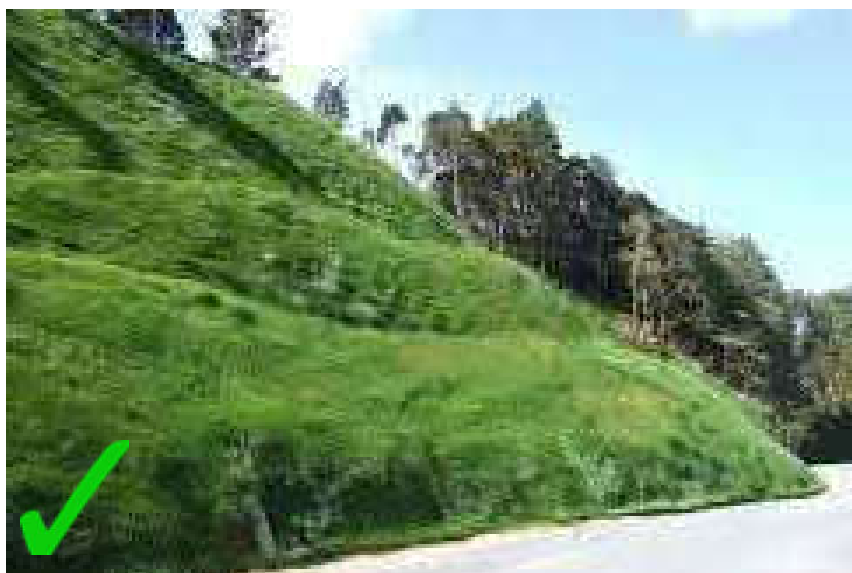
Fig. 39 Avoid benching in even steps.

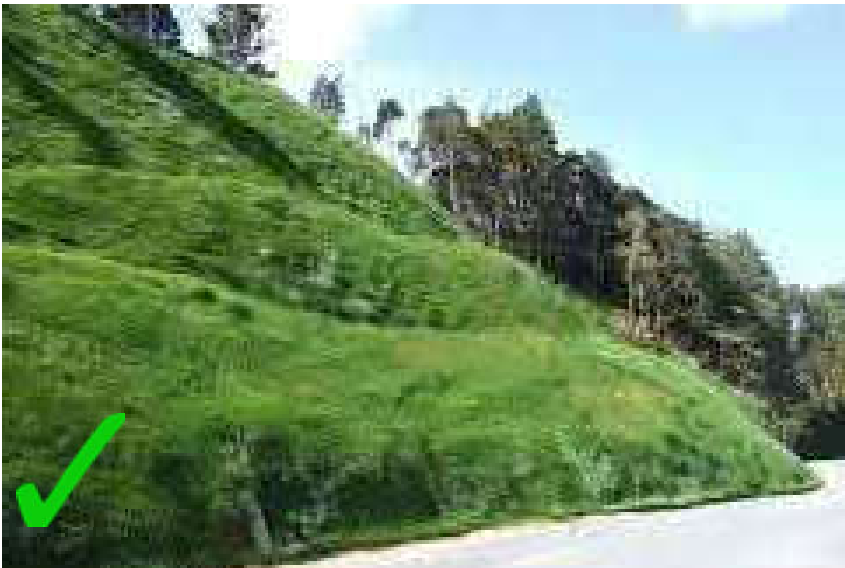
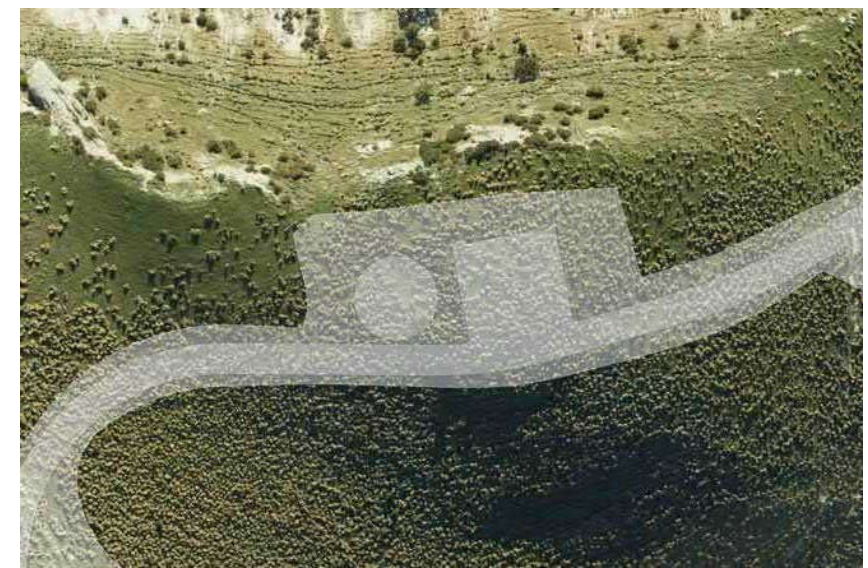
Fig. 47 Tussock grassland with 8m cuts into Amuri dip slope at turbine A18.

**(ii)** Cutting of benches adjacent to the road and platforms. All limestone material is to be crushed and used for fill in designated fill and disposal areas, where it will be placed on the adjacent landform, shaped and covered with topsoil. Cut benches are to be formed at, for example turbine A18, where the vertical height is approximately 8.0m. (see Figure 47)
